Wascana Centre Authority

Comprehensive Review Project

Building and Infrastructure Assessments

September 2012

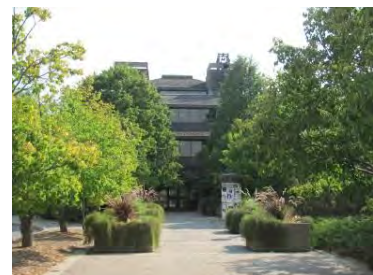
2.1.1 2900 Wascana Drive – Wascana Place (Area 2)

The facility sits on a concrete foundation complete with concrete slab on grade. Stained cedar walls and a cedar shake roof covering provide the envelope for the facility. Cedar walls and cedar shakes installed on the roof have become damaged and worn and require replacement. One large skylight has been installed. Exterior doors in the facility are aluminum, steel or wood. Exterior steel doors have worn finishes as does the exterior wood door. Exterior windows in the facility are aluminum. Overhead doors in the facility are wood. Overhead wood doors in the facility are sagging and worn and require replacement.

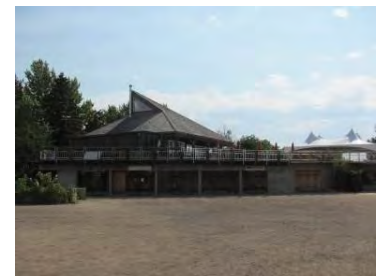
2.1.2 3000 Wascana Drive – Wascana Marina (Area 2)

The facility substructure consists of concrete strip footings, foundation walls, and slab on grade. Exterior walls are cast in place concrete below grade with wood cladding above grade. Exterior windows are sealed units set in wood frames in the original building, and aluminium framed windows in the 2005 addition. The original exterior passage wood windows are deteriorating with localized rot and should be replaced. The solid wood exterior doors have some damage that should be addressed and the 2005 addition steel doors are in good condition. The overhead doors on the lower level are solid wood barn door style. A small portion of the flat roof covered with SBS roofing is retaining some water ponds and the insulation should be re-sloped and roofing replaced.

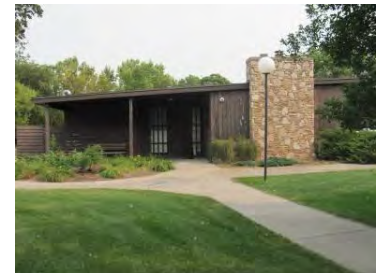
2.2.1 3201 Broad Street – Central Depot (Area 3)

The facility substructure consists of concrete strip footings, foundation walls, and slab on grade. An extreme amount of water was noted in the basement of the facility and corrosion was noted on structural teleposts. Retain a foundation consultant to analyze and make recommendations for remediation. Exterior walls are clad with wood siding which is damaged and requires attention. Exterior windows are sealed units set in wood frames. Exterior passage doors include both solid core wood and insulated steel units. Other doors include a 10' x 7' sliding wood door that is damaged and an 8' x 8' overhead door. The roof covering is a rolled bituminous membrane (SBS) that was installed in 2008.

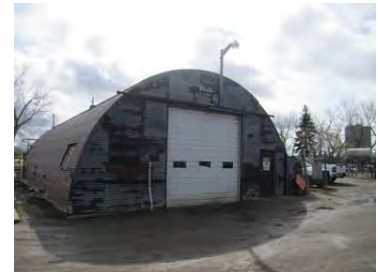
2.2.2 3300 Broad Street – Quonset (Area 3)

The facility substructure consists of concrete strip footings, foundation walls, and slab on grade. Exterior walls and roof are constructed of painted galvanized ribbed steel. The paint finish is worn and exterior walls are damaged on north side. Exterior windows are single glazed units set in steel frames. These windows do not provide proper heat and energy management. Exterior passage doors include insulated steel units. Other doors include a 12' x 12' overhead door complete with motorized operation.

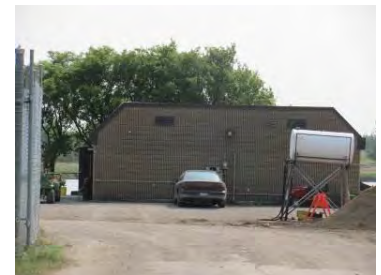
2.2.4 551E Assiniboine Ave – Area 4 Service Depot (Area 6)

The facility substructure consists of concrete strip footings, foundation walls, and slab on grade. Exterior walls are clad with cadenza concrete masonry units. Exterior windows are single glazed units set in wood frames. These windows are worn and energy inefficient and require replacement. Exterior passage doors include insulated steel units. Other doors include three 10' x 11' overhead doors that are worn and are approaching the end of their serviceable life. The roof covering is a BUR roofing with sheet metal flashing. BUR roofing contains soft spots and has approximately 5 years remaining.

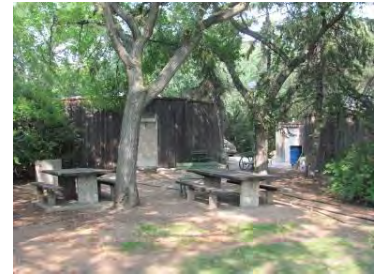
2.2.5 2860 Wascana Drive – Goosehill Service Depot (Area 4)

The facility substructure consists of a concrete foundation and slab on grade. Exterior walls are clad with wood siding which is damaged and requires attention. Two exterior passage doors are insulated steel. The door at the fuel storage shed has a damaged frame and the paint has deteriorated on both the fuel storage room door and the main entrance door. There are two overhead coiling doors – one to the garbage storage and the other to the main shop area. Both are in good condition however the jambs require replacement. The flat roof covering appeared to be in good condition and was recently replaced. The building has no windows but instead has eight acrylic skylights.

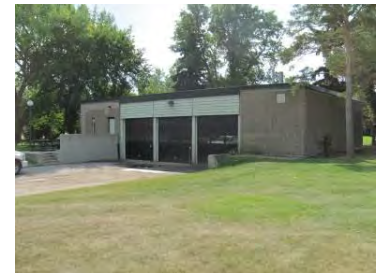
2.2.6 1955 College Ave – Area 2 Service Depot (Area 1)

The building is founded on cast in place concrete strip footings and slab on grade. The glulam timber roof beams with tongue and groove fir decking are supported on load bearing interior and exterior concrete masonry with fluted 'Cadenza' exterior finish. The mechanical mezzanine floor is constructed of 2 x 6 joists at 12" on centre. The span of the joists is of concern and may require additional support. Retain a structural engineer to analyze and make recommendations for remediation. This issue should be repaired as soon as possible. The exterior windows are double glazed sealed wood units with localized rot and should be replaced. The exterior passage doors are metal clad and the three overhead doors are wood. The BUR roofing requires replacement.

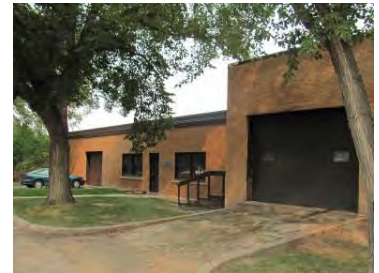
2.2.7 Area 1 Service Depot (no Civic Address, by Legislature) (Area 3)

Substructure components noted during the assessment include a cast concrete floor that had significant damage and requires replacement. It was noted that a concrete basement (104' x 32') is located nearby and is deemed a liability. The wood stairs leading into the building are deteriorating and require attention. Exterior walls are clad with a brick veneer and were noted with extreme cracking that requires further analysis. Due to the extreme cracking and shifting of the concrete foundation, exterior brick walls and interior concrete masonry units, a structural consultant should be retained to analyze the condition of the building and makes recommendations for correction. Exterior windows include sealed aluminum framed units as well as single glazed wood framed units that should be replaced. Exterior doors include a steel clad door with a worn paint finish and solid core wood doors that are dated and worn. Three overhead doors were in place. The roof covering consists of both tar and gravel (BUR), and a bituminous sheet membrane (BUR).

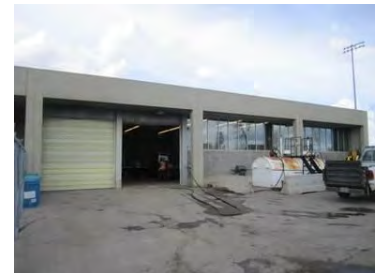
2.2.8 Campus Service Depot A (Area 7)

The facility substructure consists of concrete strip footings, foundation walls, and slab on grade. Exterior walls are concrete masonry units with wood soffits. The pointing is damaged on the CMU wall. Exterior passage door include an exterior aluminum door. Other doors include two 12' x 12' overhead doors. One unit is constructed of a vinyl/plastic material while the other is wood constructions. Both overhead doors are damaged and worn. Access to the roof was not permitted.

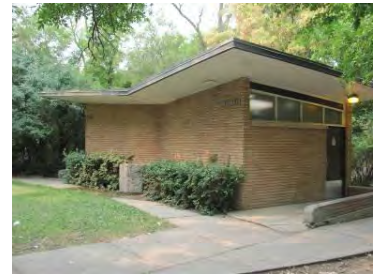
2.3.1 2801 Albert Street – Washroom #1 Legislature (Area 3)

The facility is supported on a concrete slab on grade. The ground should be re-graded to slope away from the building. The walls are wood stud construction with brick on the exterior. Some graffiti was noted during the site visit and caulking at the masonry joints requires replacement. The roof is wood framed with built up roofing and is in fair condition however the plaster coating at the soffits needs repair. Wired glazing set in wood frames is cracked in at least three panels and the paint is worn. The three steel passage doors require repainting. There are two skylights in the building and they are in good condition.

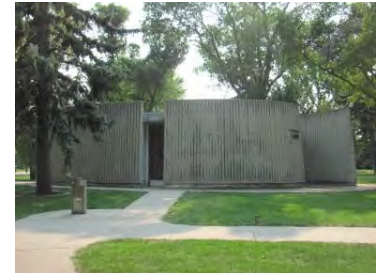
2.3.2 3200 Lakeshore Drive – Washroom #2 (Area 3)

The facility is supported on a concrete slab on grade. The walls are cast in place concrete construction with a bush hammered fluted face. The roof is also cast in place concrete. The paint on the three steel passage doors is worn and the wooden transoms are rotting and will soon require replacement. There are two 36" diameter skylights in the building and they are in fair condition. The BUR roofing is in poor condition and should be replaced along with the associated flashing and trim.

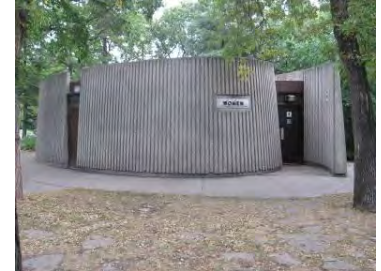
2.3.3 Washroom #3 (Area 1)

The facility is supported on a concrete slab on grade. The walls are cast in place concrete construction with a bush hammered fluted face. The roof is also cast in place concrete. The three steel passage doors are in good condition. There are two 36" diameter skylights in the building and they are in fair condition. The BUR roofing is in poor condition and should be replaced along with the associated flashing and trim.

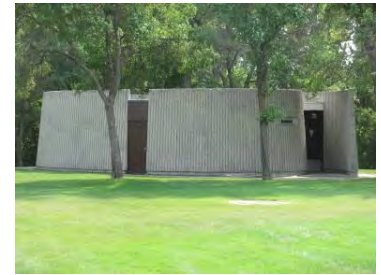
2.3.4 Washroom #4 (Area 4)

The facility is supported on a concrete slab on grade. The walls are cast in place concrete construction with a bush hammered fluted face. The roof is also cast in place concrete. The three steel passage doors are in good condition. There are two 36" diameter skylights in the building and they are in fair condition. The BUR roofing is in poor condition and should be replaced along with the associated flashing and trim.

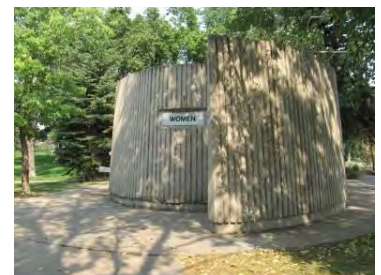
2.3.7 2881 Wascana Drive – Washroom #7 Candy Cane Park (Area 4)

The facility is supported on a concrete slab on grade. The walls are cast in place concrete construction with a bush hammered fluted face. The roof is also cast in place concrete. The three steel passage doors are in good condition. There are two 36" diameter skylights in the building and they are in fair condition. The BUR roofing is in good condition.

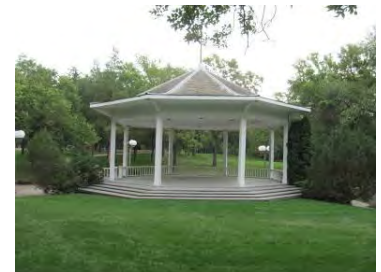
2.4.1 19th Ave & Smith St – Bandshell (Area 1)

The flooring of the bandshell consists of 2x6 timber decking on 2x10 timber joists. Some of the boards are rotting and require replacement. The aluminum stairs are in good condition. The cedar shake roofing, galvanized ridge caps, galvanized flashing, and the timber framing supporting the roof appears to be in good condition. An attic hatch is framed through the 4" tongue and groove timber ceiling cladding.

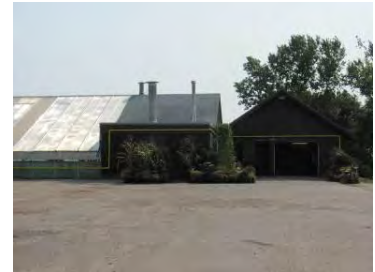
2.4.2 217E Assiniboine Ave Greenhouse Complex including the Header House (Area 6)

Exterior walls are clad with numerous types of construction including CMU, metal siding, cementitious stucco, wood siding and glass and polycarbonate material for the greenhouses. The CMU, wood siding and glass exterior walls are all worn or damaged. A significant amount of water was noted in the concrete bunker area of the facility. A structural consultant should be retained to analyze the foundation of the building and make recommendations for remediation. Exterior windows are primarily sealed units set in wood frames with some upgraded PVC units installed. Exterior passage doors include both solid core wood and insulated steel units. The large wood exterior doors should be replaced by a steel overhead door. Other doors include a 9'x7' steel overhead door and 11' x 9' wood overhead door. The wood overhead door is worn and requires replacement. The roof covering is a rolled bituminous membrane (SBS), an inverted roofing system, asphalt shingles, sheet metal and glass/polycarbonate panels for greenhouse. The inverted roof section requires replacement.

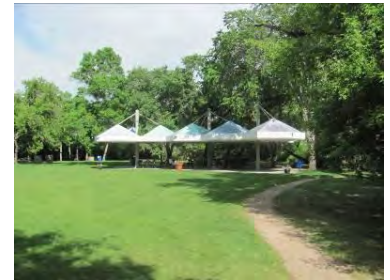
The structure sits on a concrete foundation. The concrete foundation was noted to have minor cracking. Patch cracks and monitor. Four triangular steel columns hold up 12 fibreglass hexagon shaped canopies. Connections between the top of the columns and the roof panels are provided by steel rods with turnbuckles. The columns, rods and roof panels are all in good condition. The fibreglass roofing units are painted. Paint finishes on the roof are worn and require painting.

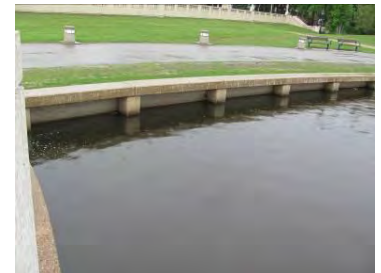
3.6.1 North Shore Retaining Wall (Area 1)

The north shore retaining wall was constructed in 2004 and is constructed of concrete panel sections and concrete wall sections on piles with an exposed aggregate finish. In general, the wall is in good condition and at the northeast a void is to be filled behind the wall.

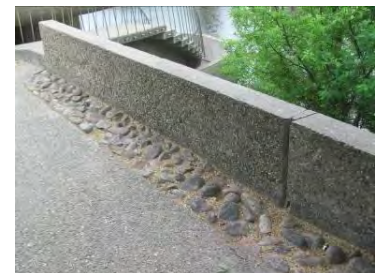
3.6.2 East Shore Retaining Wall by Willow Island (Area 2)

The retaining walls along the shore adjacent to the Willow Island Overlook were constructed in 1964 and are cast in place concrete on piles with an exposed aggregate finish. In general, the walls are in good condition, however vertical cracks along control joints have developed and the cracks require sealant to prevent water migrating into the concrete.

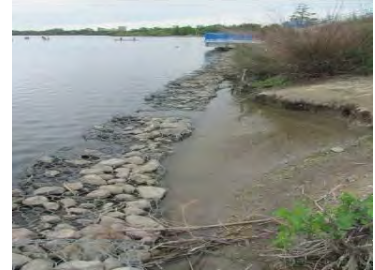
3.6.3 Pine Island Main Shoreline (Area 3)

Pine Island was constructed in 2004. The shoreline is protected by a series of gabion baskets and they are in fair condition. At the southwest corner, gabions have shifted and deformed. Gabion baskets are damaged and missing rocks along the west side. The terraced upper viewing area is constructed of cast-in-place concrete retaining walls and is in good condition.

The former bridge abutment where the new waterfall structure is supported is in fair condition and exhibits some cracking, localized damaged areas, staining and moss growth. A large vertical crack (5-10mm) at the corner between west wingwall and backwall of abutment was observed however the concrete is still sound around the crack. A large vertical crack was observed at west side of backwall (20-30 mm) and there is staining and weak concrete. On the east side of the backwall, a concrete core (300 mm deep X 100 mm diameter) was observed as well as an intermediate crack (4mm) with weakened concrete around damaged area. A large vertical crack (15-20 mm) was also measured. Along the top of the backwall, the concrete is damaged and a crack (2 mm) is located where the wingwall meets the backwall on the east side. The aged concrete requires repair.

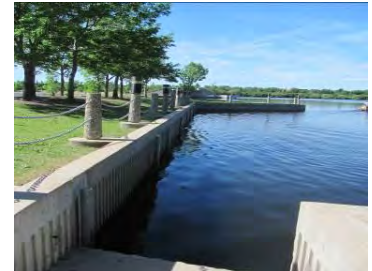
3.6.4 Marina Retaining Walls (Area 2)

The retaining walls surrounding the marina were constructed in 1974 and consist of cast in place concrete on piles with an exposed aggregate finish. In general, the walls are in good condition.

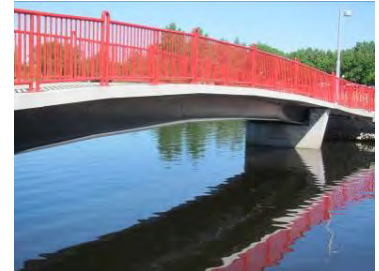
3.7.1 Broad Street Pedestrian Bridge (Area 2)

The bridge was constructed in 2010 and is a three span steel girder main span bridge with cast in place deck jump spans and concrete deck. The bridge is in very good condition.

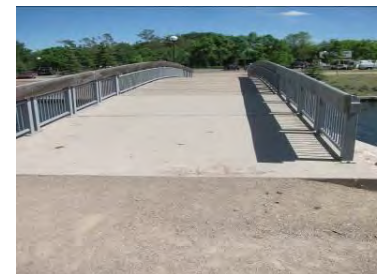
3.7.3 Pine Island Pedestrian Bridge (Area 3)

The bridge was constructed in 2004 and is a single span steel through truss bridge with wood decking and is in good condition. Some settlement has occurred along the west sides of both approach pathways and additional granular fill is required. Timber decking at the south abutment is to be repaired, guardrail bolting at one location on the east needs tightening, and guardrail spacer blocking on the west requires replacement. Portions of the grouted rip rap at the headslopes of both abutments are missing and require replacement.

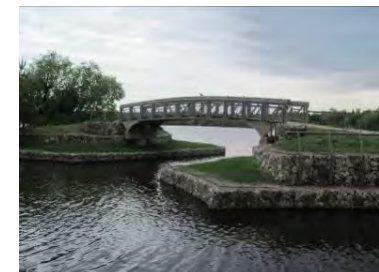
3.7.4 Trafalgar Pedestrian Bridge (Area 2)

The bridge was constructed in 2002 and is a single span steel through truss bridge with wood decking and is in good condition. The guardrail fastening on the southeast should be repaired. It was observed that the steel bearing plates were installed with a slight overhang at both abutments on the north edges; one overhangs by 8 mm and the other by 20 mm. No action is recommended at this time, but should be monitored in future inspections.

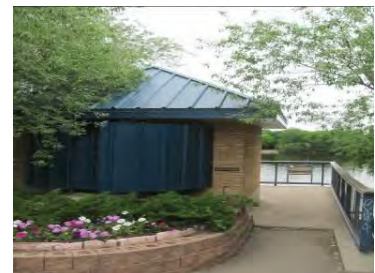
3.8.2 Legislative Pump House (Area 3)

Constructed in 1958, the pump house contains both irrigation pumping and cooling pumps for the Legislature powerhouse. Several modifications to the pump house have been made since 1958 including addition of the electrical superstructure in the 1970's and grating platforms at the water level and docks in 2001. The Legislative overlook structure is at a separate location and its assessment is summarized in another section.

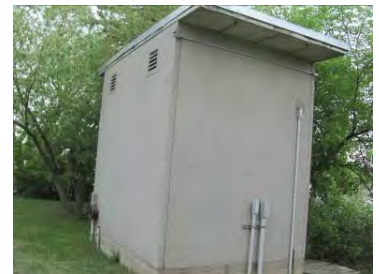
The single vertical turbine pump and the sliding gate valve that isolates the wet well from the lake are in fair condition. The remaining piping, valves and pressure indicator are in good condition. The screen was not accessible to review.

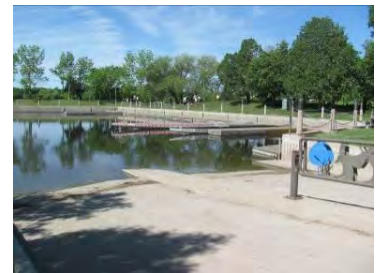
3.11.1 Wascana Marina Dock System (Area 2)

The Wascana Marina docks are constructed of 2x6 pressure treated plywood decking with 2'x6' cross members at 2' on centre. There are 24 docks. Year of construction is unknown. Some light damage is visible. Metal connections are in good shape, some localized rust. Dock #14 South (not labelled) has a chipped and damaged connection to Dock #14 West Dock that should be repaired.

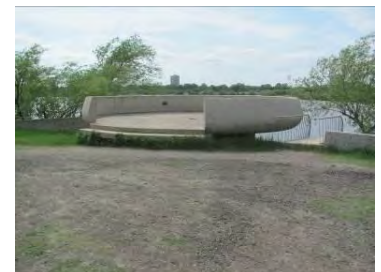
3.12.1 Douglas Park Overlook (Area 6)

The overlook was constructed in 1968 and is integrated with the Douglas Park Pump House structure. The overlook portion of the facility consists of a cast in place concrete deck in a circular shape with a monolithic concrete perimeter wall atop the pump house. The overlook is in fair condition but requires attention in several locations. The gravel should be re-graded and vegetation be removed at the entrance to minimize the step up to the overlook deck slab. The membrane protecting the concrete deck has worn and requires replacement. The concrete deck slab and perimeter wall is pocked and cracked. One of the stairs down to the lower concrete deck is severely damaged and requires replacement. The retaining walls adjacent to the structure exhibit vertical cracks at control joints and require sealant to prevent water migration.

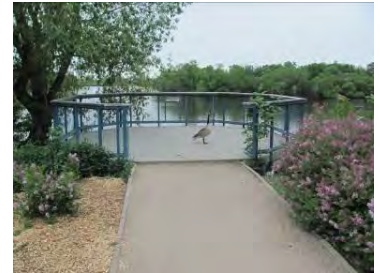
3.12.2 South Shore Overlook (Area 3)

The overlook is built of steel support beams, wood framing, and composite decking supported on concrete foundations. Year of construction is not known. It is in fair condition due to the condition of the concrete piles – three out of four concrete piles are cracked at the top and require repair.

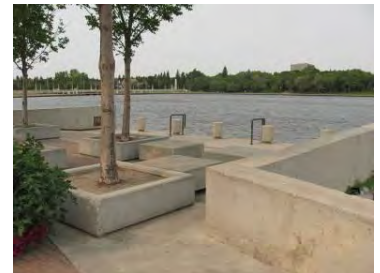
3.12.3 Legislative Overlook (Area 3)

The overlook was constructed in 1980 and is constructed out of cast in place concrete walls, benches and planters. The slab consists of sections of cast in place concrete and red brick. There are several locations where the brick is damaged and needs to be replaced.

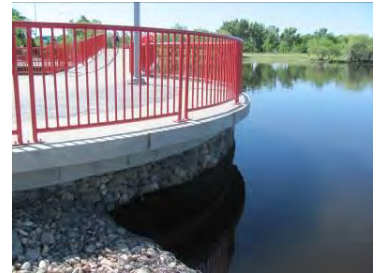
3.12.7 Broad Street Pedestrian Bridge Overlook (Areas 2 & 3)

The overlooks are the approaches to the pedestrian bridge and the Broad Street Underpass. Built in 2004, they are constructed of cast in place concrete slabs and retaining walls. In general the overlooks are in good condition.

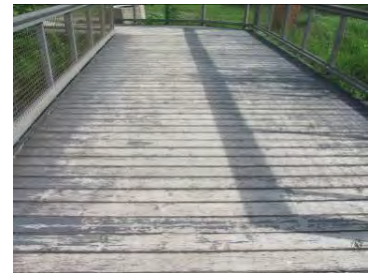
3.12.8 Candy Cane Park Overlook (Area 4)

The overlook was constructed in 1968 and consists of steel framing, timber decking and concrete pile supports. In fair condition overall, there are indications that the abutment foundation wall may have moved and requires stabilization.

A steel bearing plate at the abutment has crushed the grout underneath; therefore the grout requires replacement and the anchor bolts should be repaired. The timber decking also requires repainting and localized repairs.

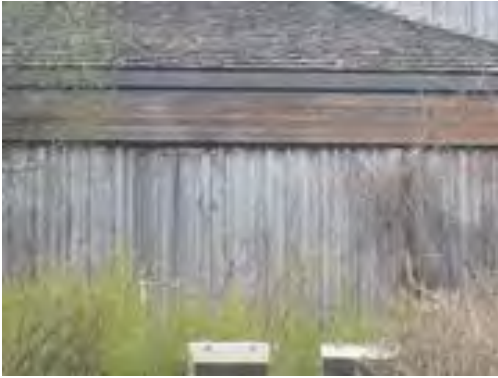
Wood Siding - Northwest

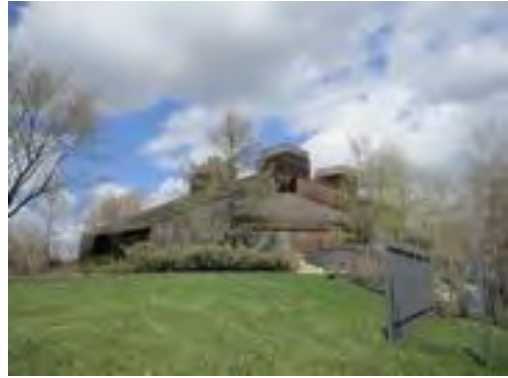
South Elevation

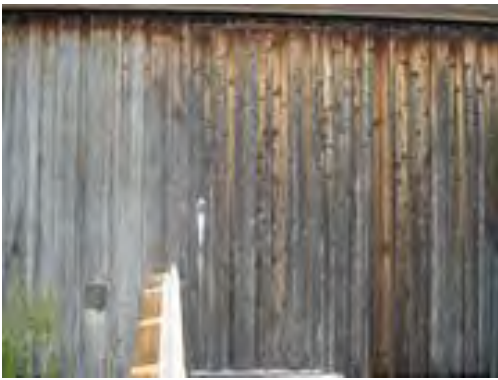
Ext Wood Door - South

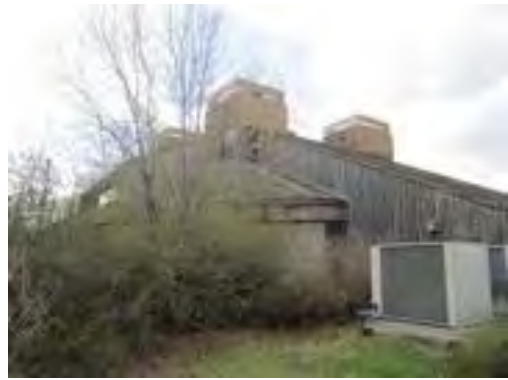
Southeast Elevation

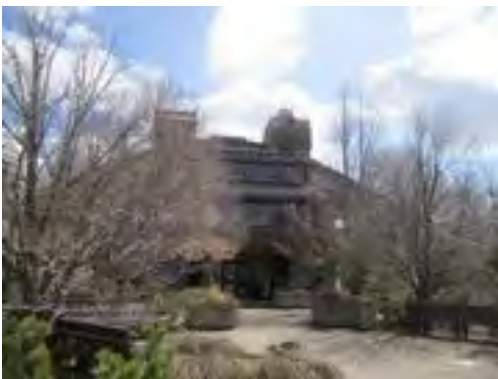
West Elevation

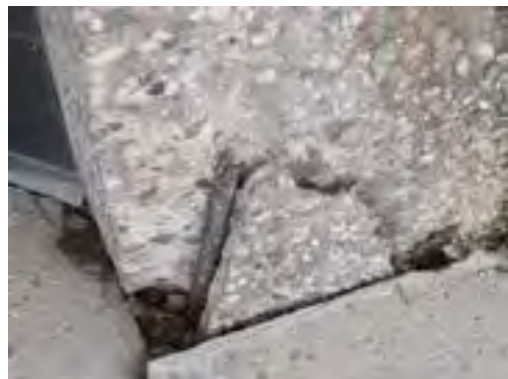
Ext Conc Wall - West

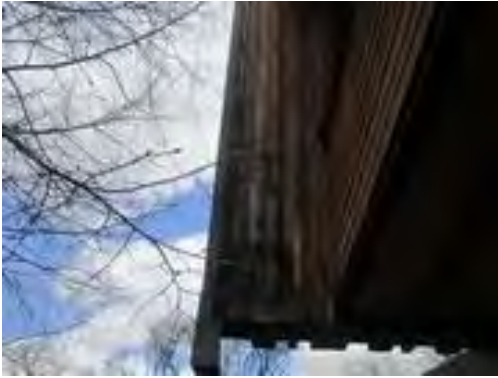
Wood Fascia Detail - West

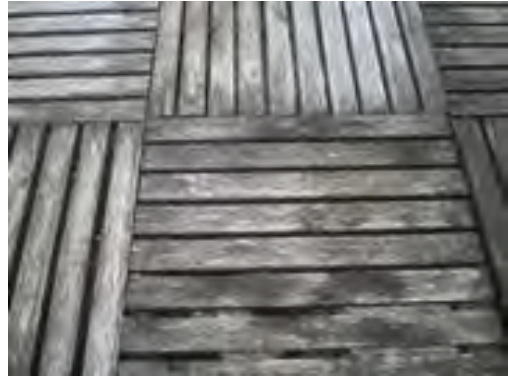
Wood Decking - West

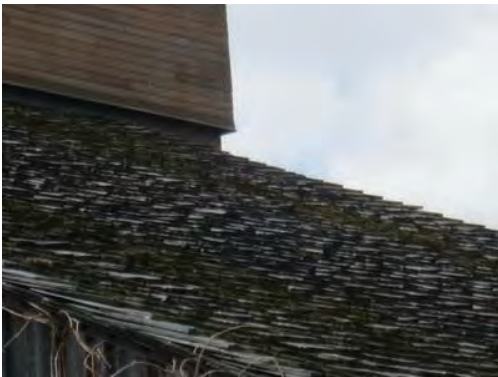
Wood Shingles - North Roof Section

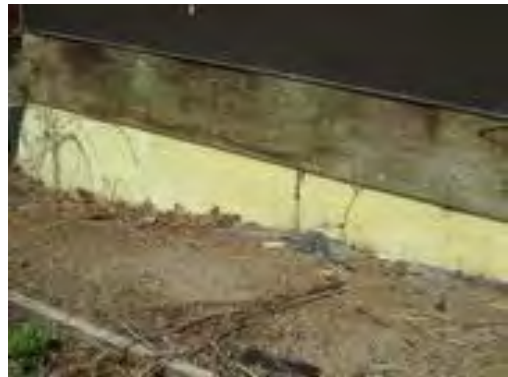
Foundation Insulation - South

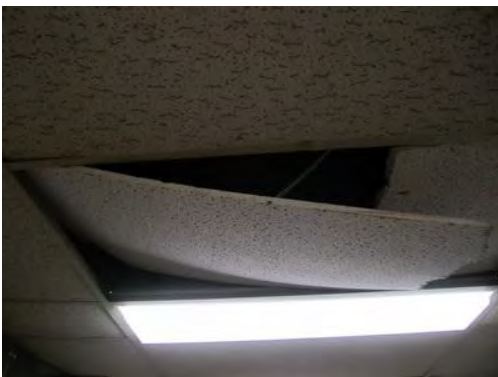
ACT Detail - Elec&Janitorial

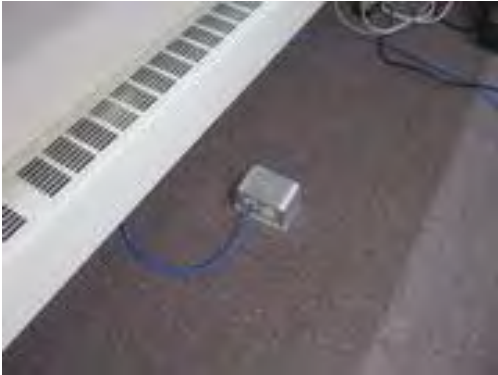
Elec Floor Box - Office Area 214

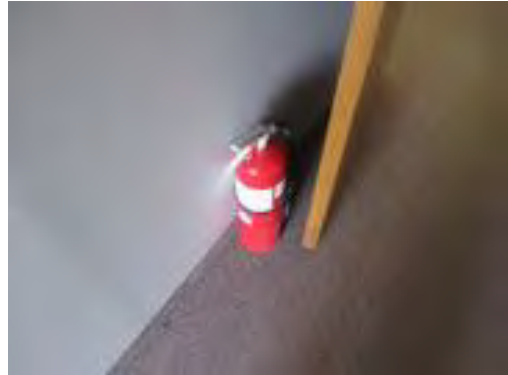
Fire Extinguisher Detail - Office 205

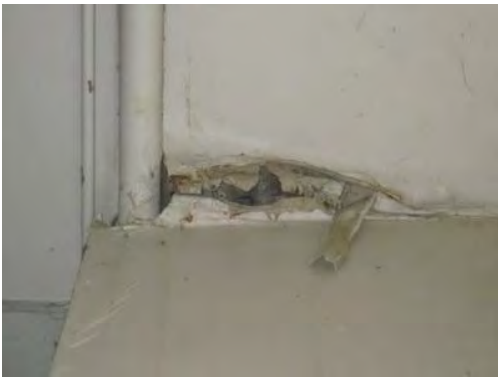
GB Ceiling Detail - Outside Mech & Elec

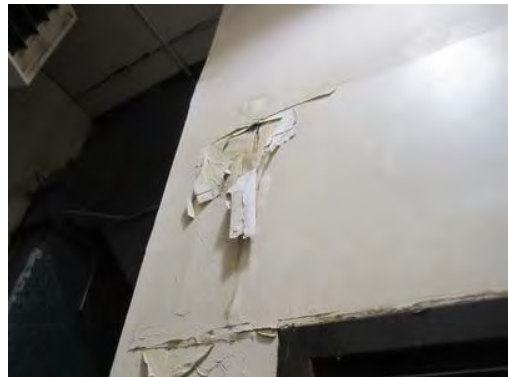
GB Wall Detail - Outside Mech & Elec

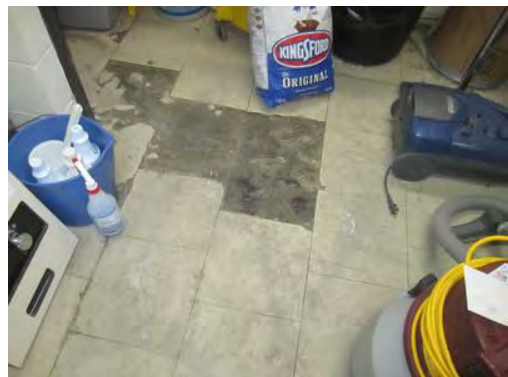
VCT Detail - Elec&Janitorial

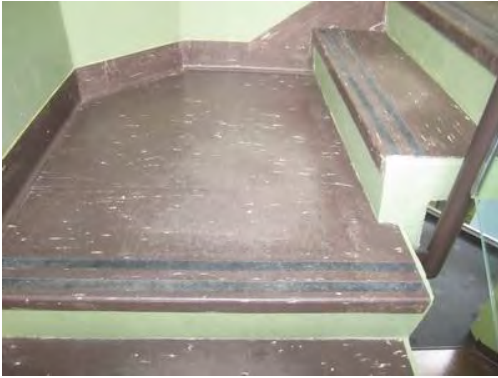
Vinyl Stair Finish - 4th Floor

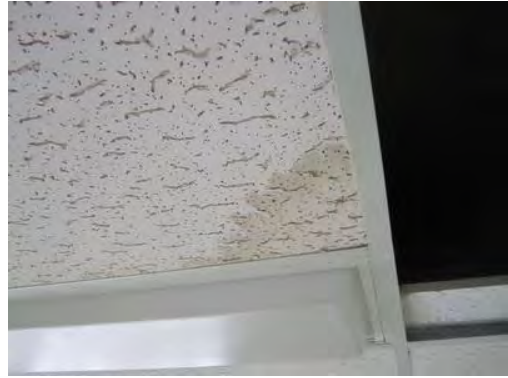
ACT Detail - 4th Floor

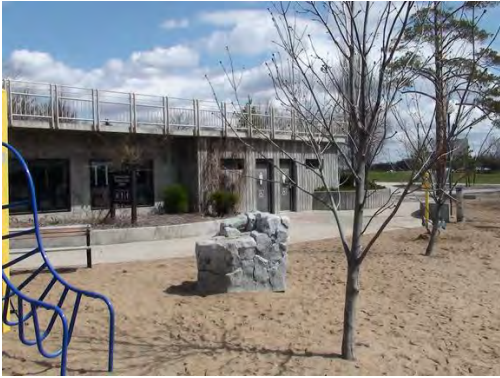
Wascana Marina-2005 Addition-Overview

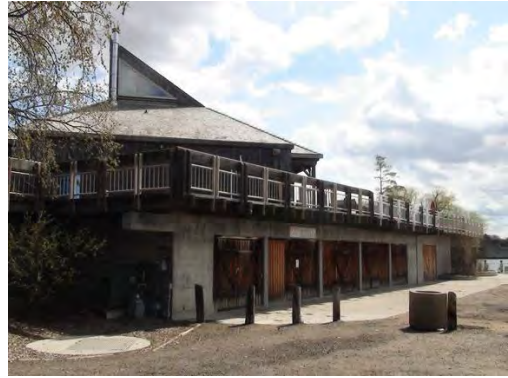
Wascana Marina-Overview

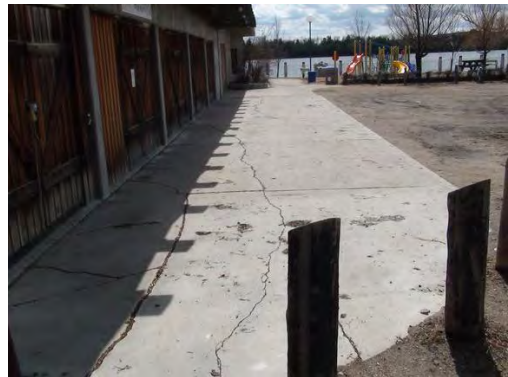
Apron Slab-Detail-Exterior

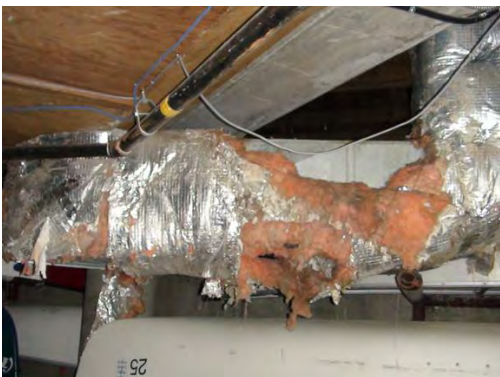
Duct1-Detail-Interior Distribution System

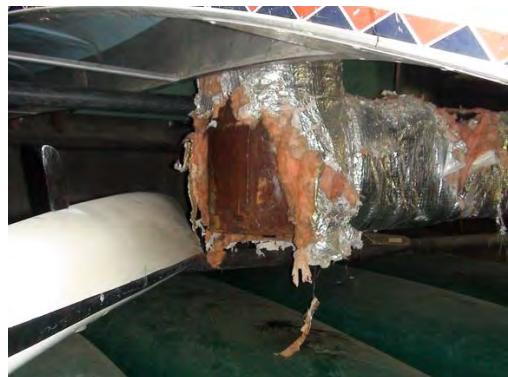
Duct2-Detail-Interior Distribution System

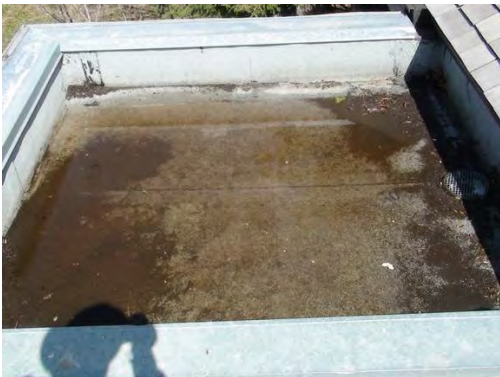
SBS Roofing-Detail-Exterior Roof Coverings

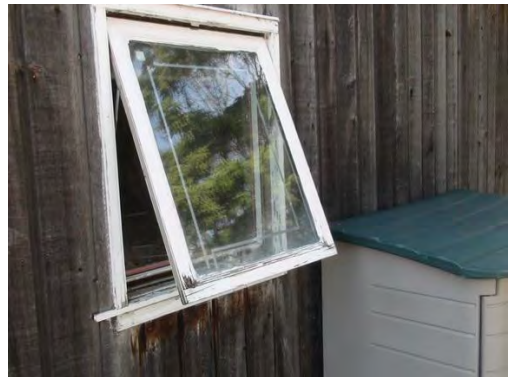
Window-Detail-Exterior

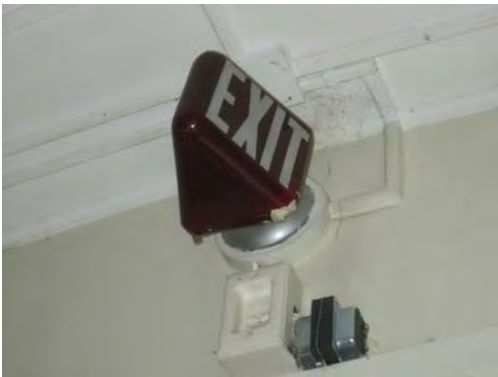
EL Exit Sign - Corridor to Garage

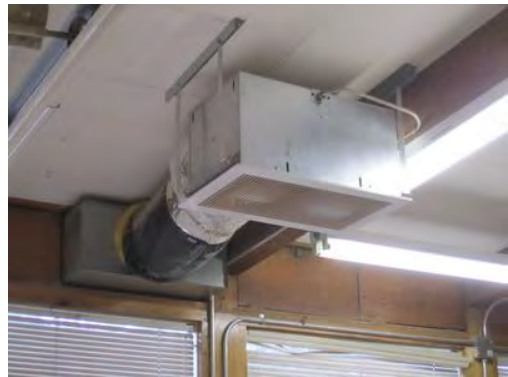
Exhaust Fan - Garage

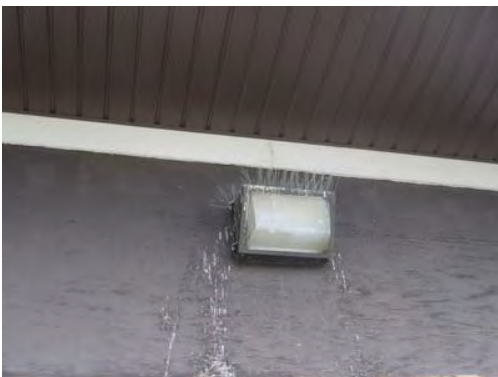
Ext HID Lighting - South (2)

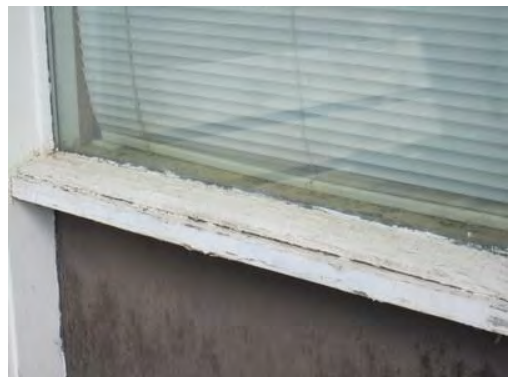
Ext Wood Windows Detail - South

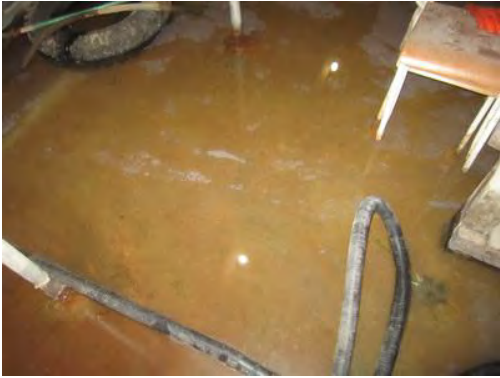
Flooding - Basement

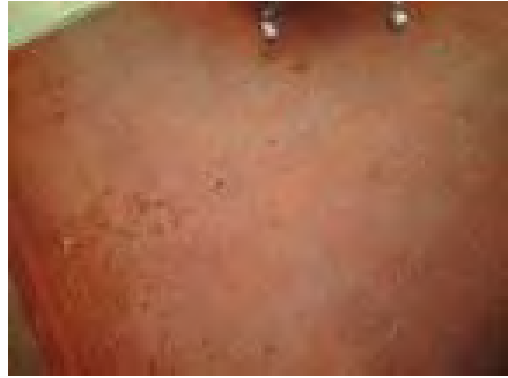
Carpet Flooring - Store Office

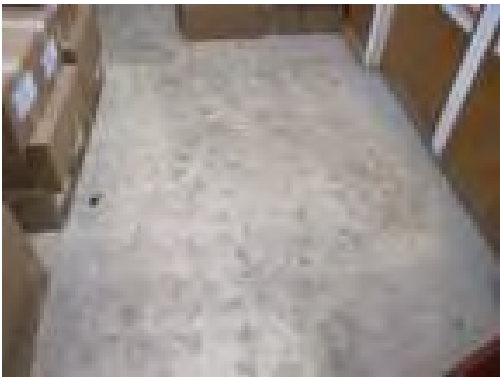
Linoleum - Store Lobby

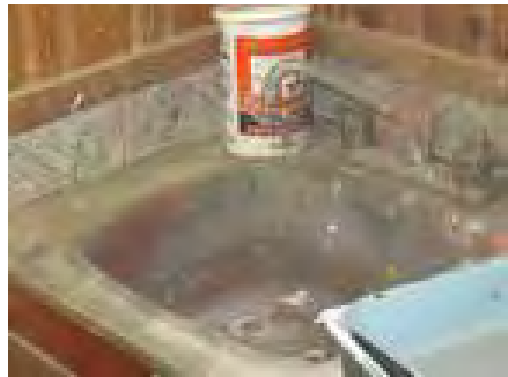
SS Sink Detail - Garage

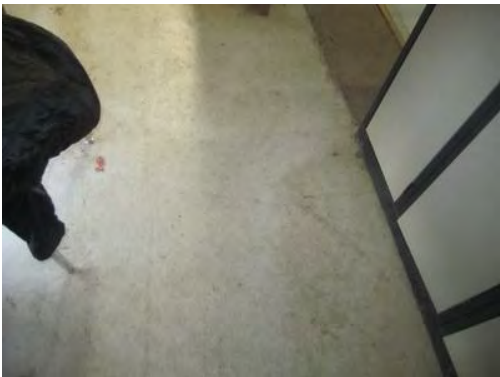
SV Flooring - Corridor to Garage

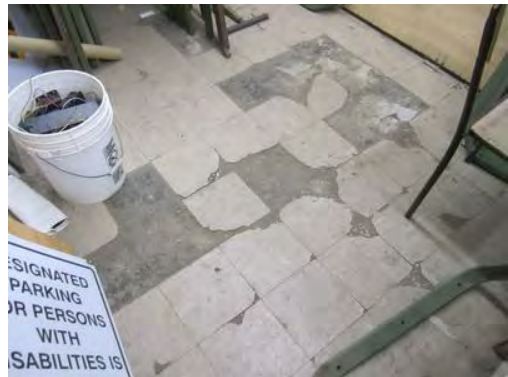
VAT Flooring - Lock Up

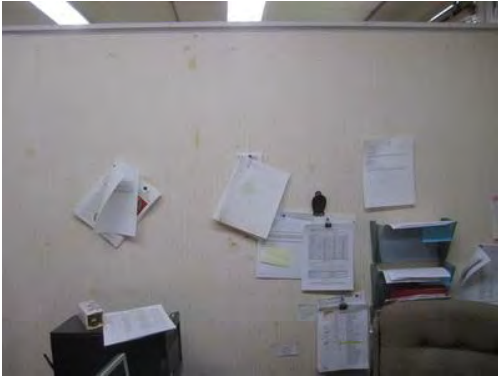
Vinyl Wall Covering - Store Office

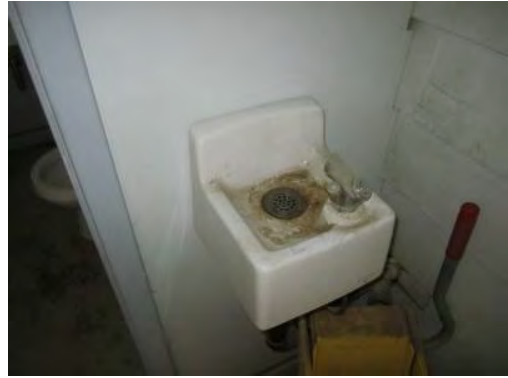
Water Fountain Detail - WR

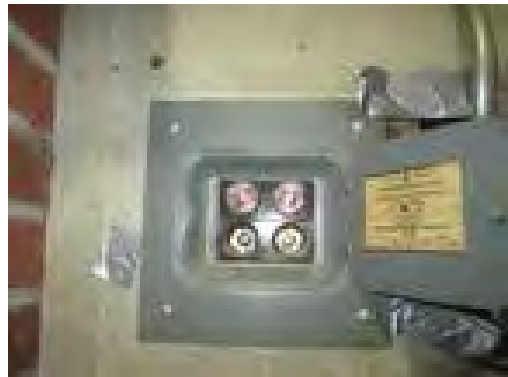
Circuit Panel - Mechanical Room

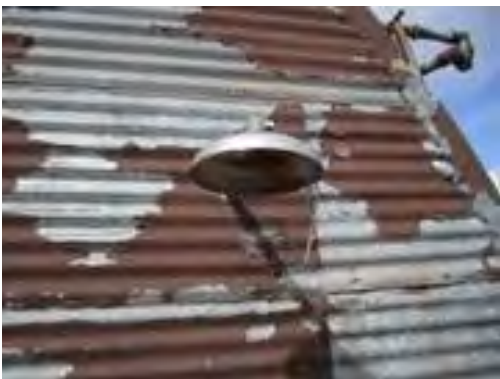
Ext Incandescent Lighting Detail - East

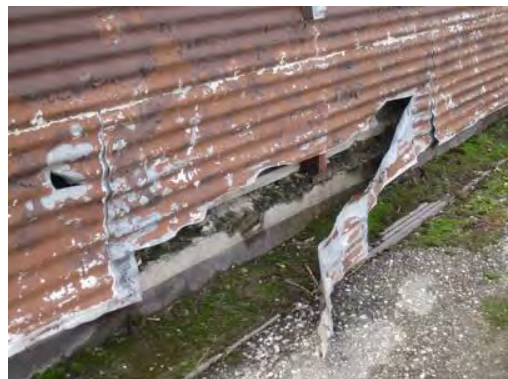
Ext Steel Siding Detail - North

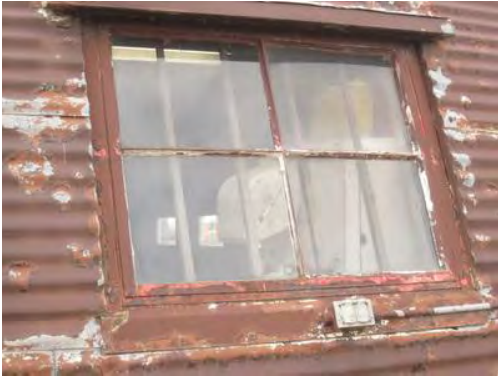
Ext Steel Window - North

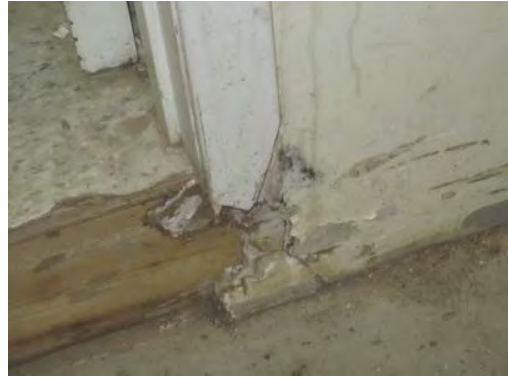
Gypsum Board Wall Detail - Washroom

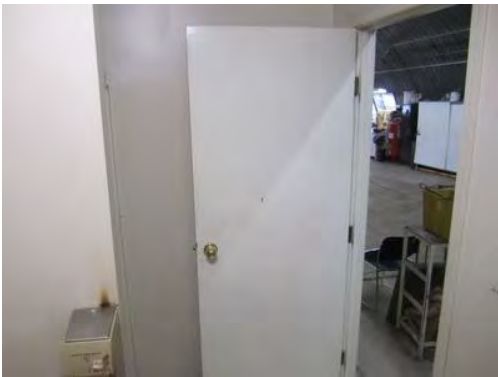
Int Wood Door - Washroom

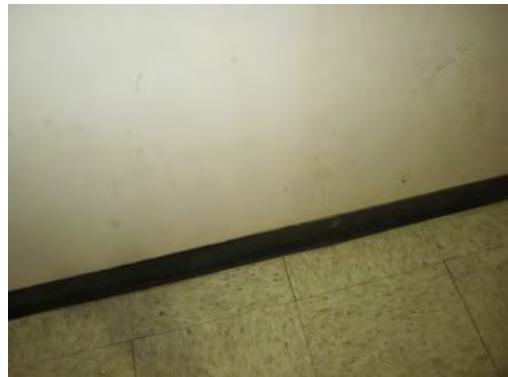
Rubber Cove Base - Washroom

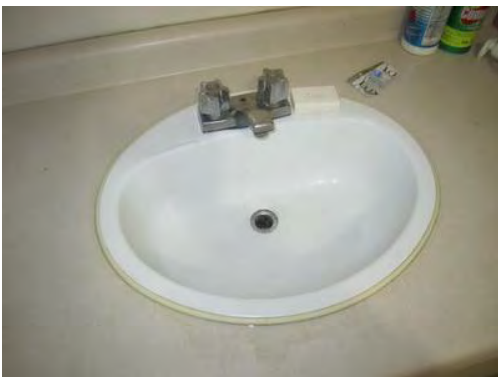
Sink - Washroom

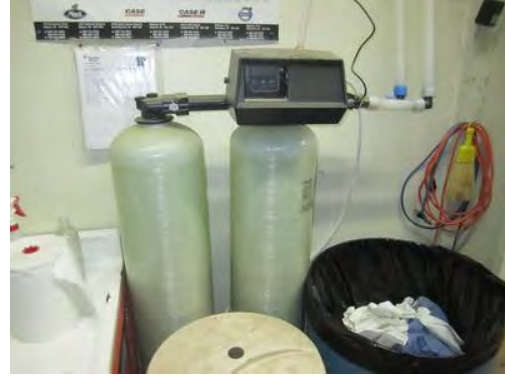
Water Softener - Lock Up

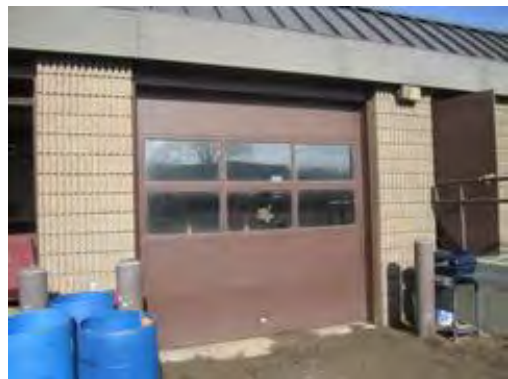
Ext Wood OH Door - East

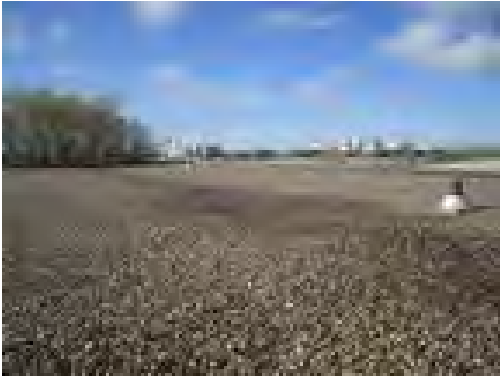
BUR Roofing

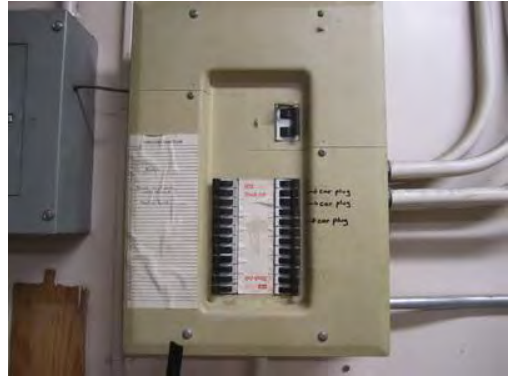
Circuit Panel - Locker Room

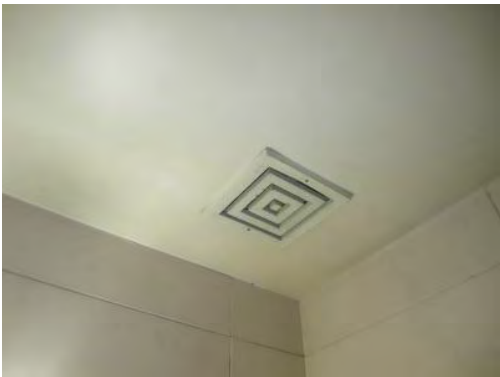
Exhaust Fan - Womens WR

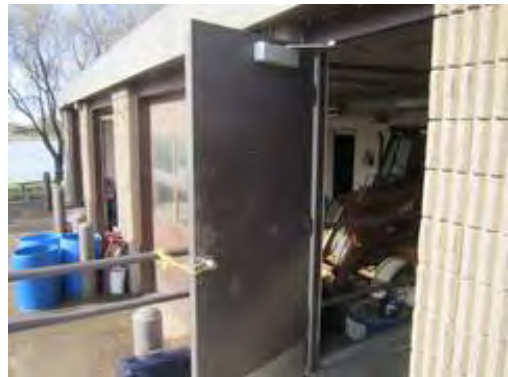
Ext Steel Door - East

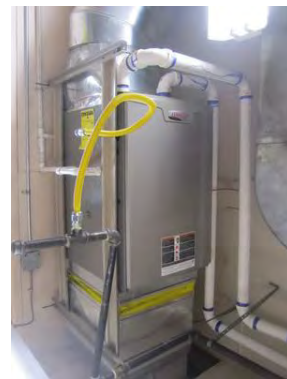
Furnace 001 - Workshop

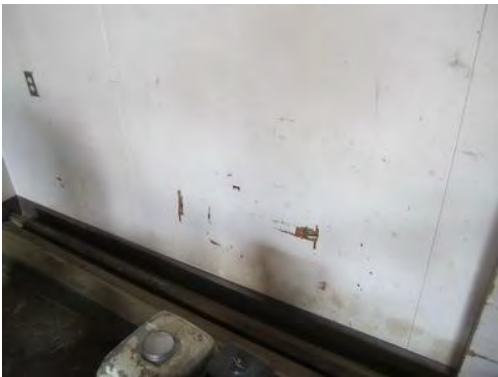
Plywood Wall Finish Detail - Shop Area

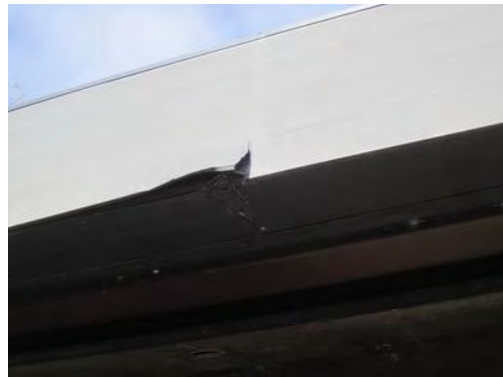
SM Flashing Detail - East

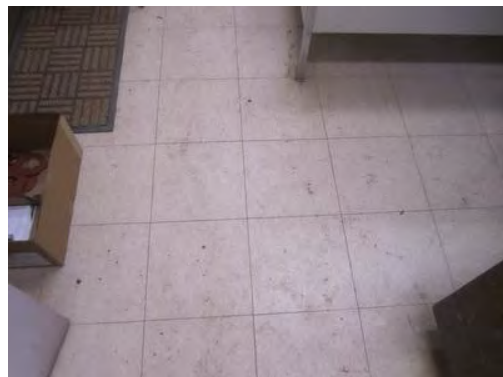
VCT Detail - Office

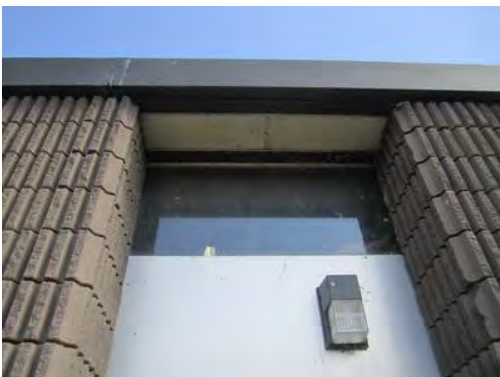
Ext Aluminum Window - South

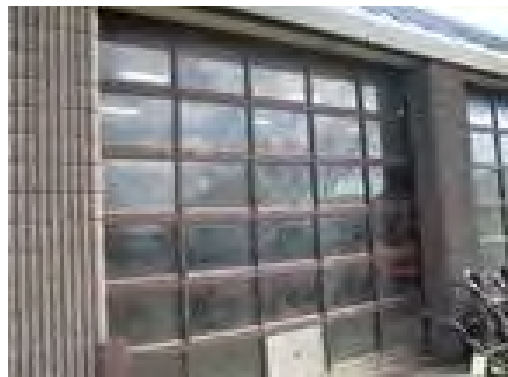
Ext OH Steel Door - South

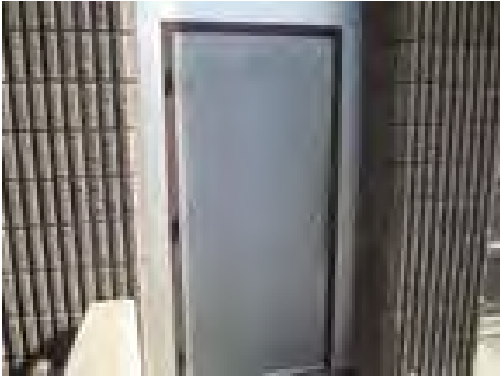
Exterior Steel Door - South

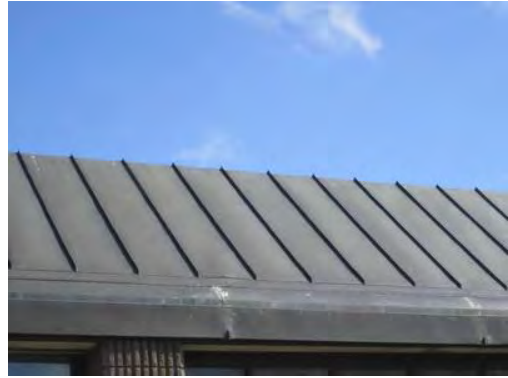
Sheet Metal Fascia - South

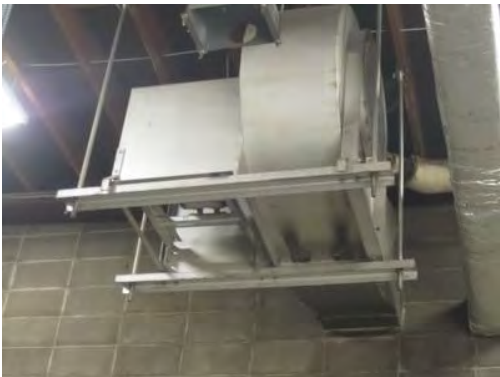
Exhaust Fan - Interior

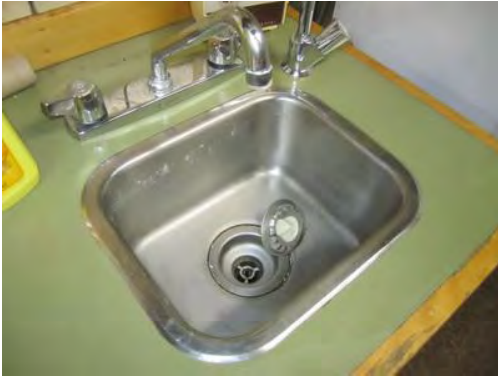
Stainless Steel Sink - Staff Room

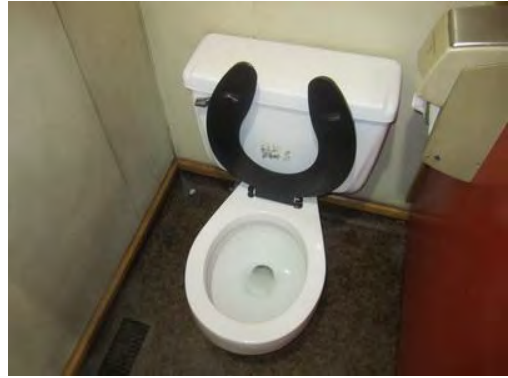
Toilet - Washroom

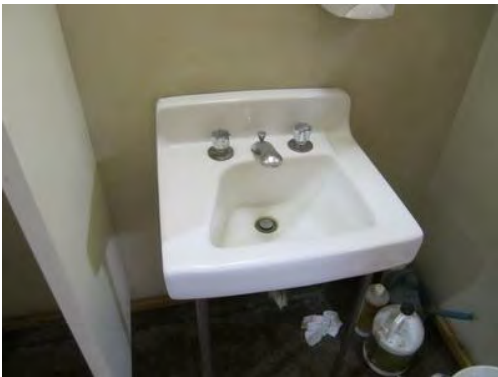
Vitreous China Sink - Washroom

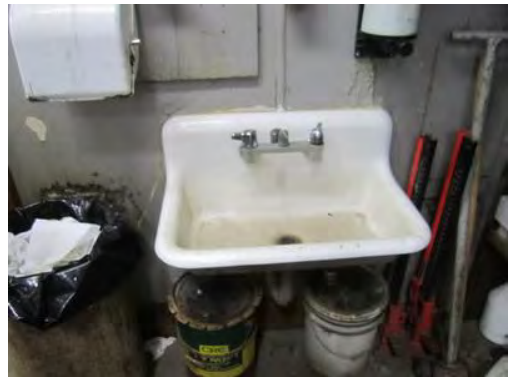
Cast Iron Shop Sink - Interior

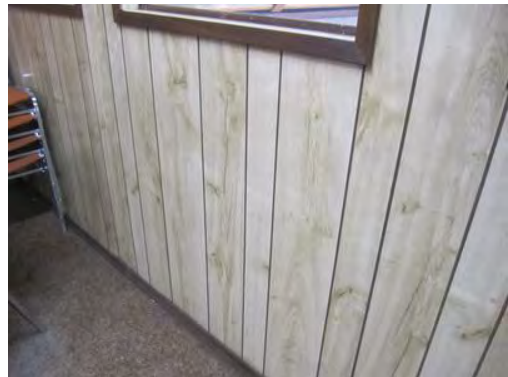
Wood Panel Wall Finish - Staff Room

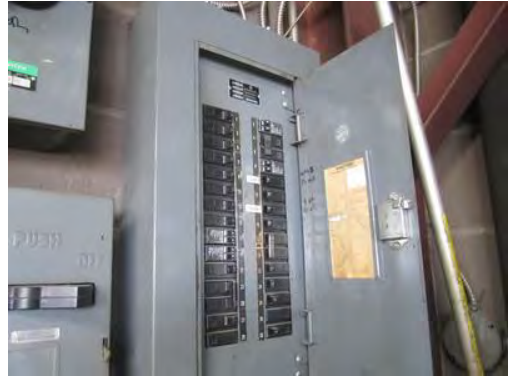
Circuit Panel - Interior

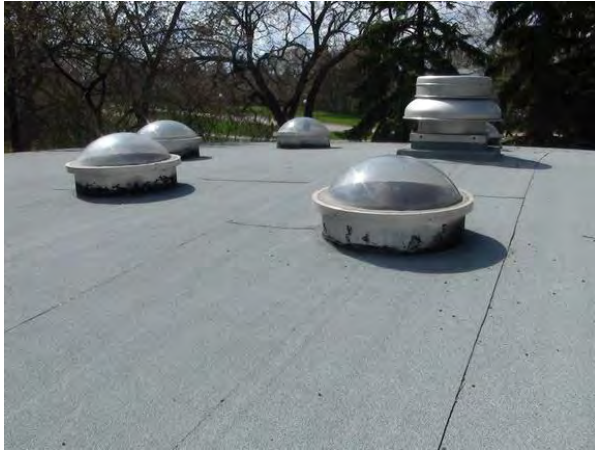
Fans Exhaust-Detail-Exterior Distribution

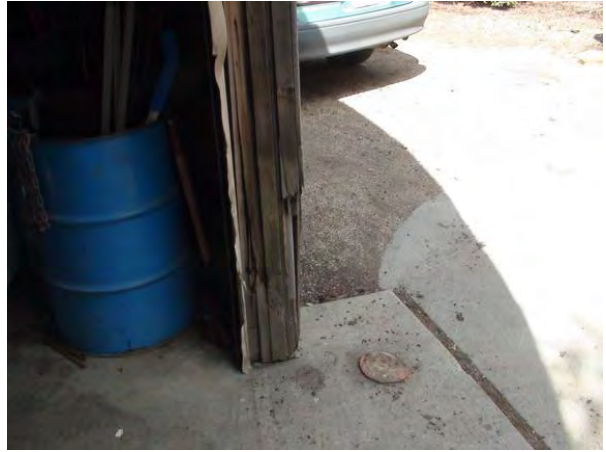
Goose Hill - Door Jamb-Detail-Exterior

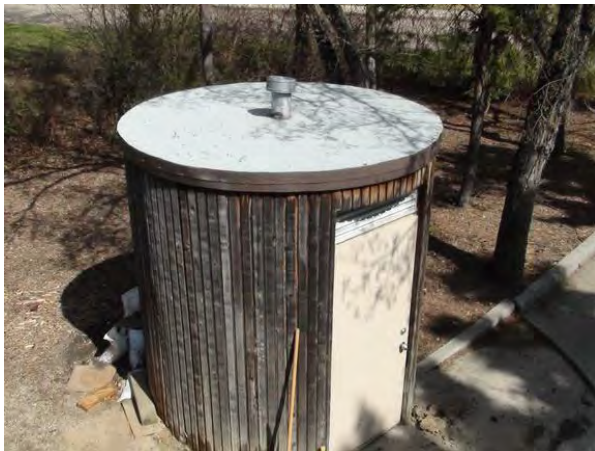
Goose Hill - Fuel Storage - Overview

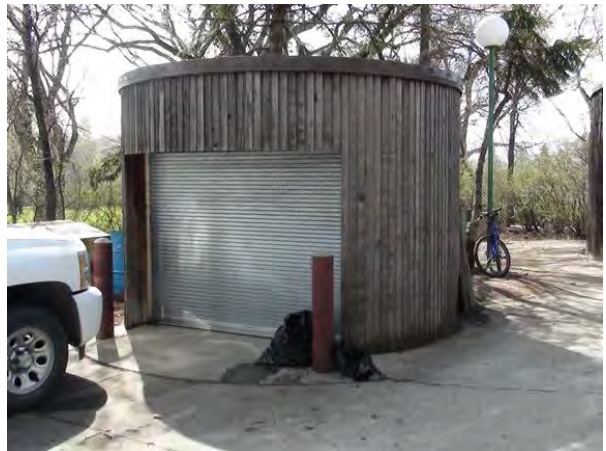
Goose Hill-Garbage Storage-Overview
